HomeTech Property Inspection Service

Property Inspection Report

920 Pelton Ave, Santa Cruz, CA 95060

Date of Inspection: 2/11/2020 Time: 9:00 AM Size: 2500
202002111

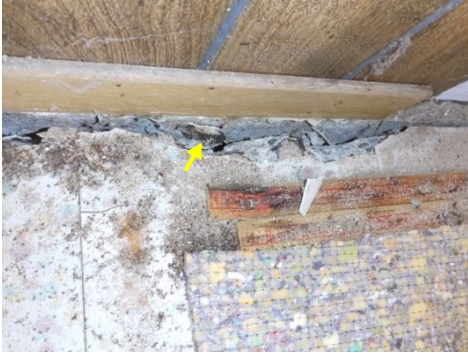
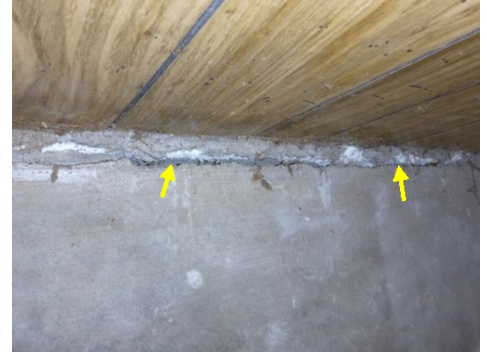
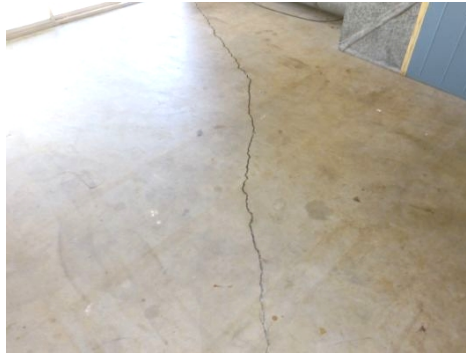
- Large cracks were observed in the concrete floor in the utility room. We recommend that a qualified licensed contractor be consulted for further evaluation and repair as necessary.
- There are gaps between the foundation and concrete slab floor along the wall where visible. These gaps appear to be part of the original construction and do not appear to be a result of structural movement.

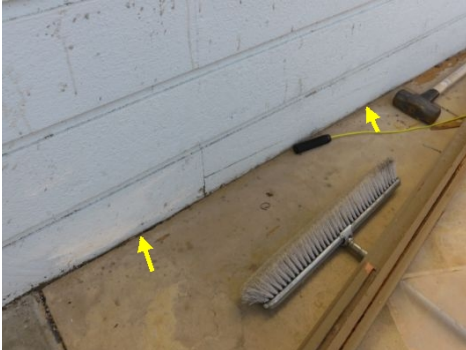
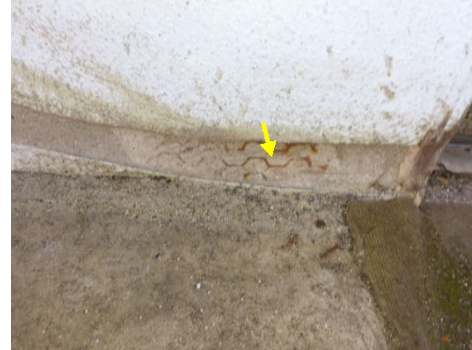
- Minor cracking was observed on the exterior stucco walls of the house. The small cracks can be scratched open, patched and sealed.
- Localized damage was observed to the stucco exterior walls on the right side of the house. Damage or deteriorated stucco should be repaired or replaced as necessary.
- Sections of the siding in the front of the house was embedded in or sitting directly on top of concrete and/or mortar. This is not an acceptable practice and can result in damage to the siding by moisture and wood destroying organisms. We recommend modification of the siding installation to eliminate direct contact between the wood and the concrete.

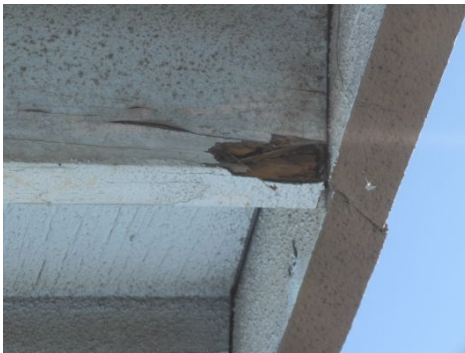
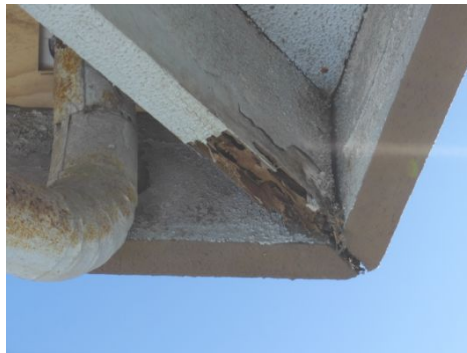
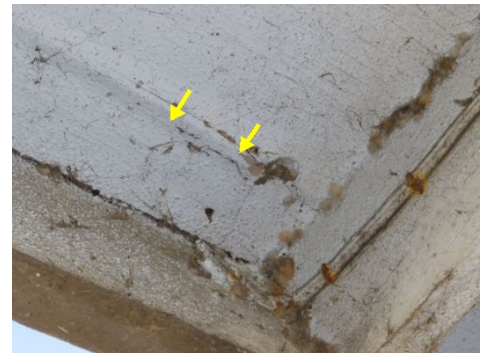
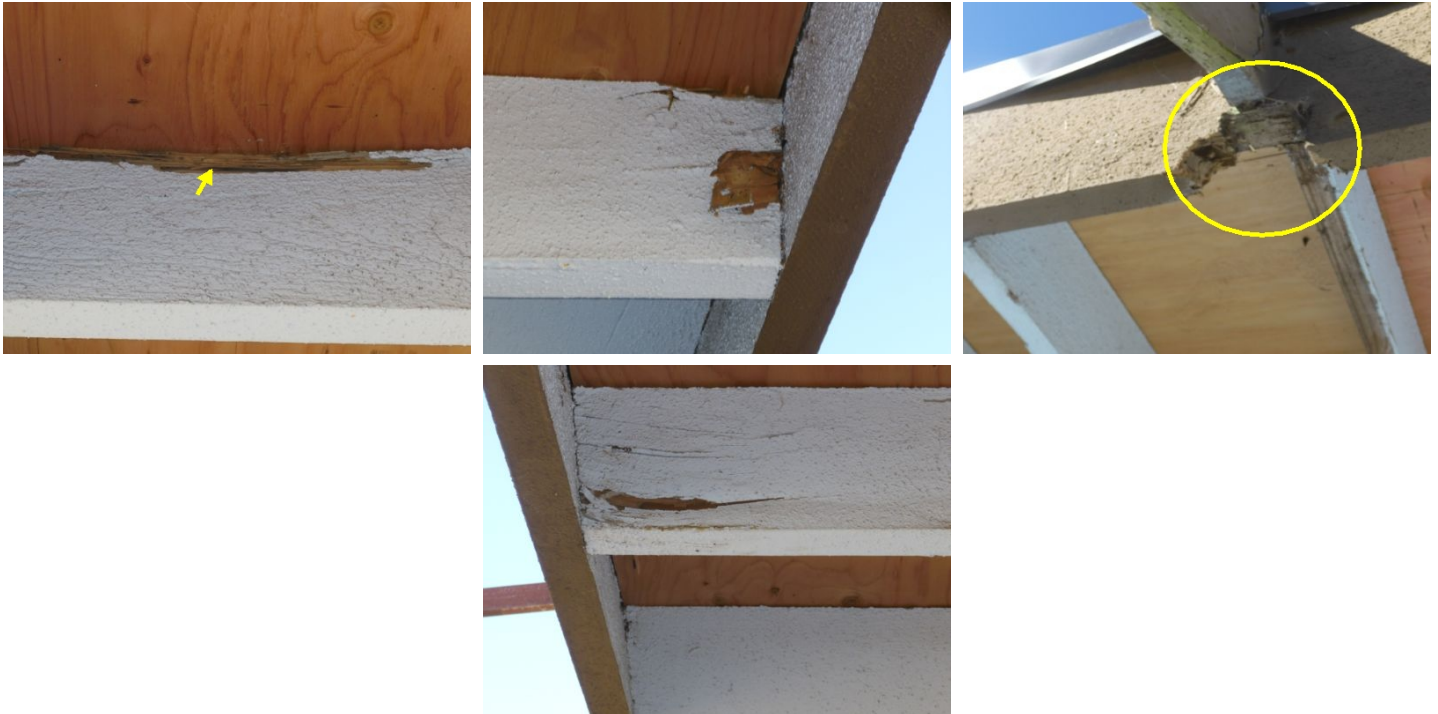
- Damage was observed on a section of the eave in the back of the house. The damaged sections of eave should be repaired or replaced as necessary. A qualified licensed pest control contractor should be consulted for further evaluation and correction.

- Evidence of mold/mildew was observed on the underside of the eaves. Mold/mildew can usually be removed with applications of a solution of household soap and water or household bleach and water prior to any repainting or refinishing. Use of a mildew resistant paint or a fungus resistant additive in the new paint will reduce the potential for return of the mildew condition.

- Rafter tail(s) are damaged on the right and left side of the house. The damaged sections of rafter tail should be repaired or replaced as necessary. A qualified licensed pest control contractor should be consulted for further evaluation and correction.

- A section of the fascia (boards nailed across the ends of the rafters at the eaves) is damaged in the front of the house. The damaged sections of fascia material should be repaired or replaced as necessary. A qualified licensed pest control contractor should be consulted for further evaluation and correction.

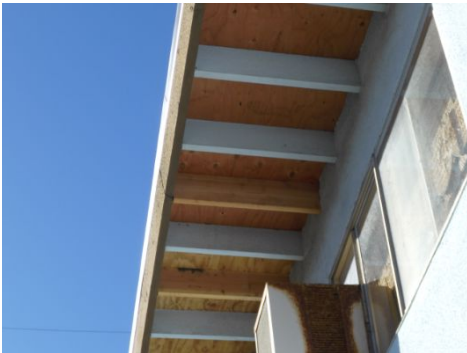
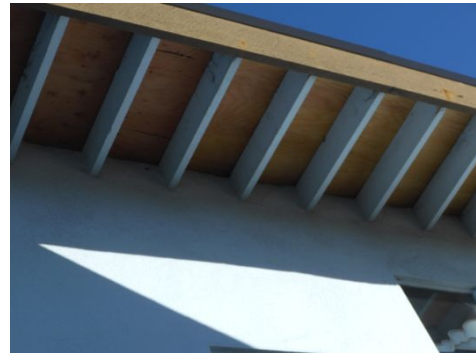
- Portions of the finish on the eave were failing or unpainted, exposing the underlying surfaces. To improve appearance, preserve the wood and extend their useful life, these surfaces should be repainted.
- Open joints and openings around wall penetrations in the siding may allow water to enter. Open joints and openings in the siding should be closed with good quality caulk and then painted to help prevent water penetration and damage to the siding and underlying building elements.

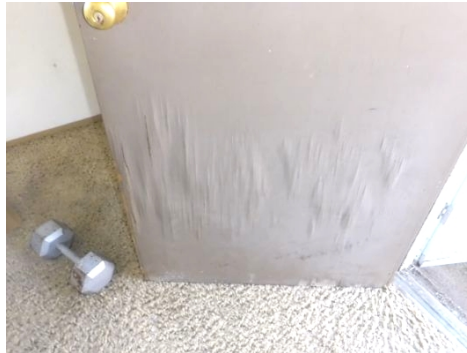
- The exterior door on the right side of the house rubbed its frame, and/or dragged on its threshold. We recommend the door and/or frame be trimmed or adjusted as necessary to restore the proper operation of the door.

- The exterior door on the right side of the house is delaminating (coming apart). Delaminated or damaged doors should be repaired or replaced as necessary.

- The sliding glass door was installed with the sliding door panel on the exterior. With this installation, it may be possible to remove the door from the outside by lifting it off the track. For security purposes, we recommend that the doors that have been installed in reverse be removed and properly installed if possible, or modified as needed to provide adequate security.

- The screen for the sliding glass door is missing. The owner should be consulted regarding screens that may be in storage. If the screens are not in storage, they should be replaced to restore protection from flying insects to the interior of the house.

- The hardware for the sliding glass door is damaged or non-functional. The exterior door hardware should be re-aligned, adjusted or replaced to restore smooth, dependable operation.

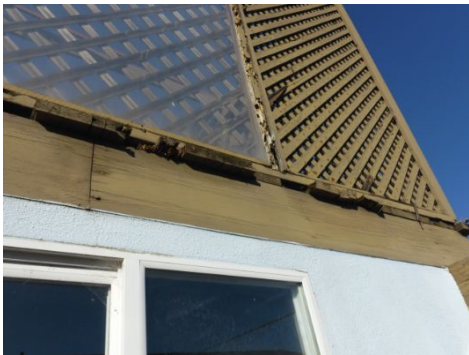
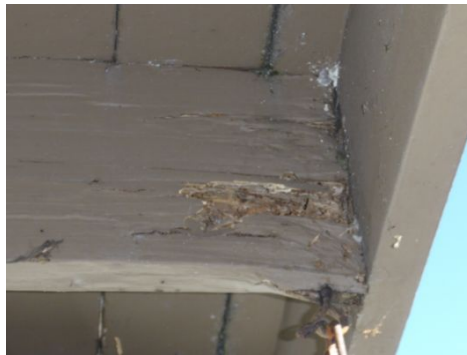
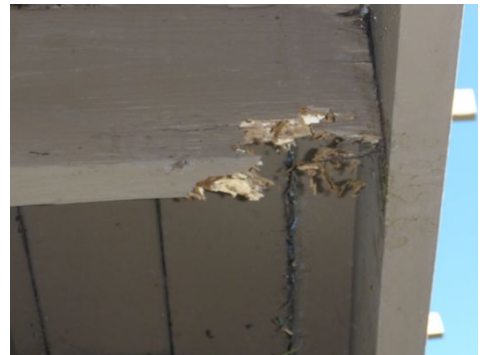
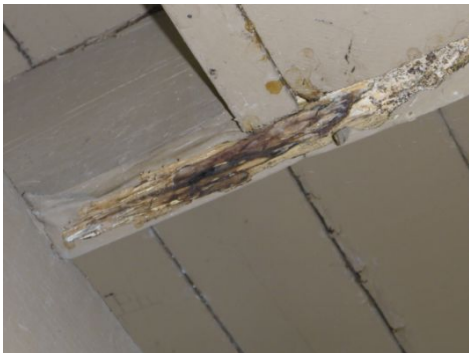
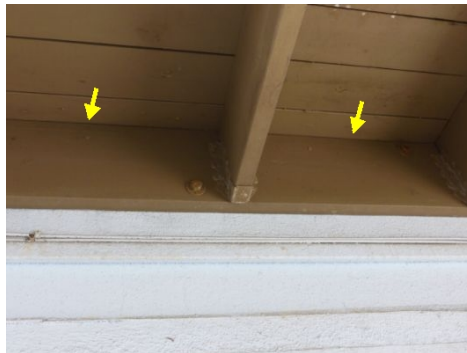
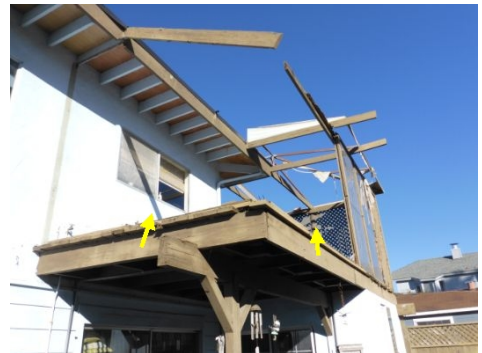
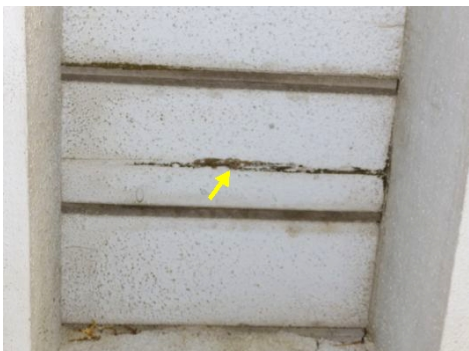
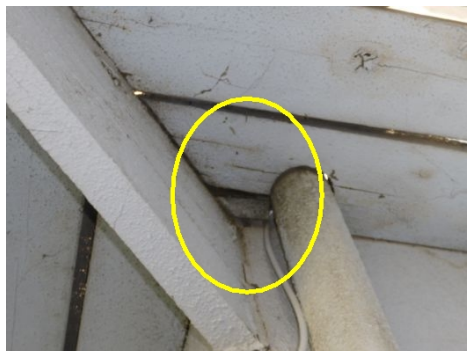
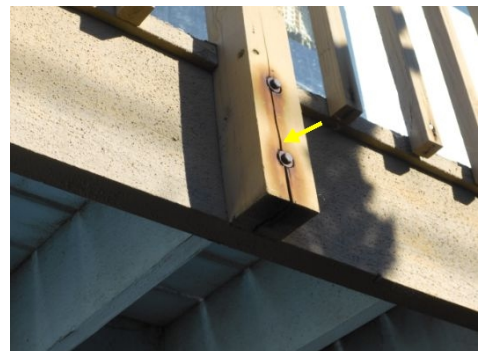
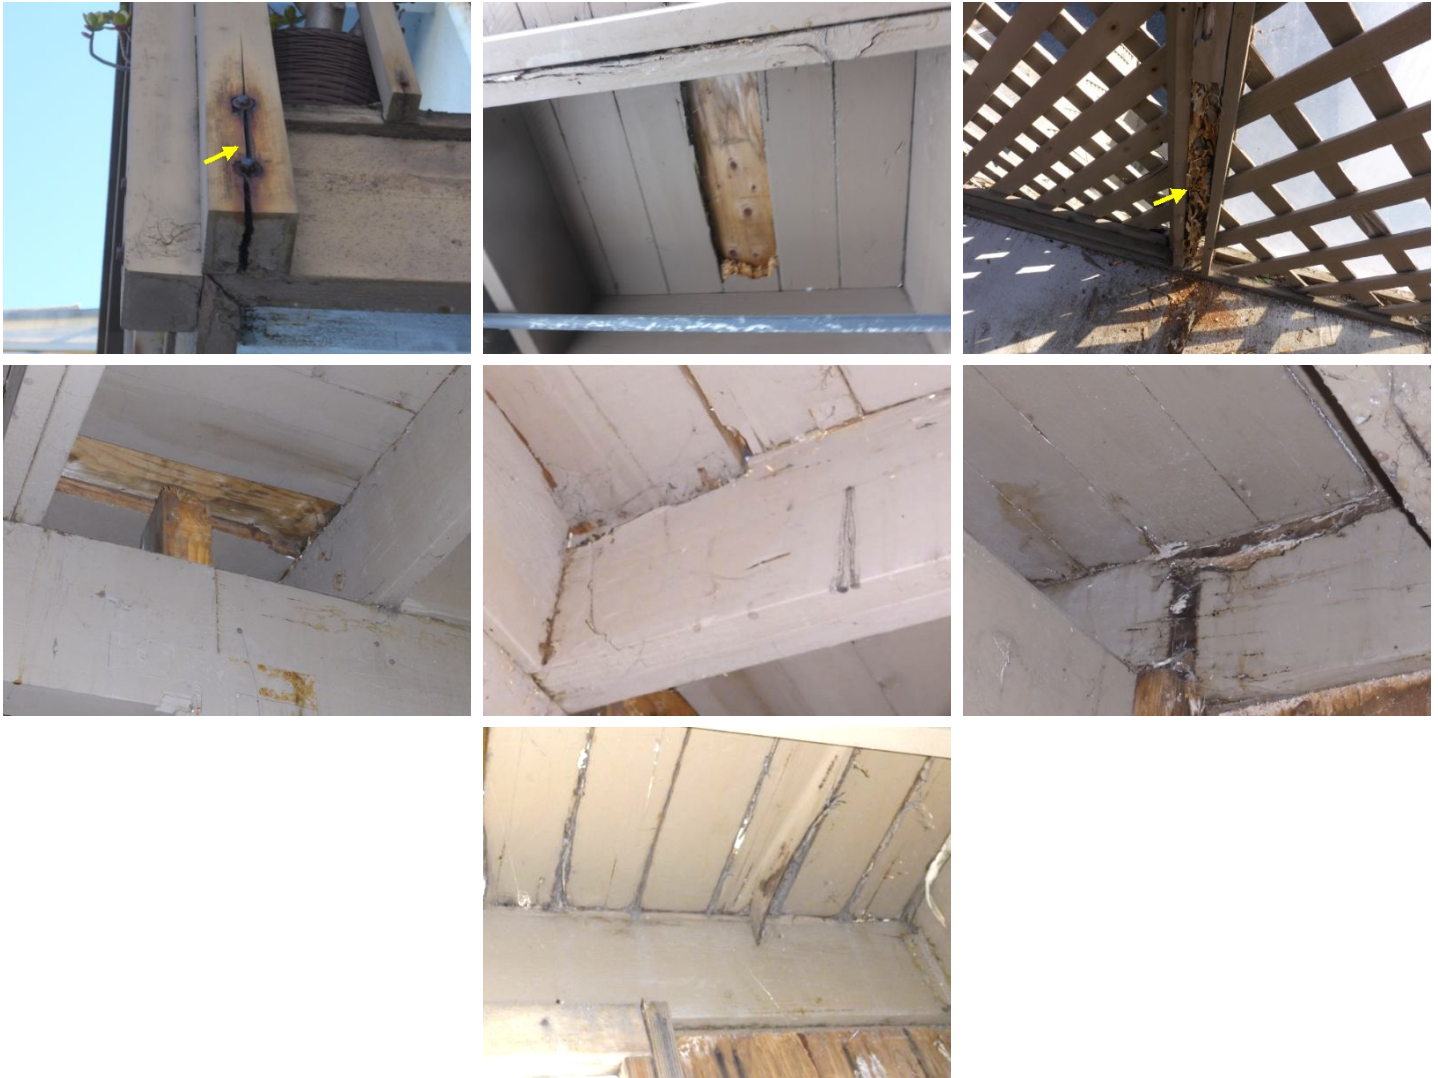
- Moisture damage was observed on portions of the deck in the back of the house. All damaged materials should be removed and replaced with material treated to resist wood destroying organisms. A qualified licensed pest control contractor should be consulted for further evaluation and correction.

- The ledger board attached to the structure to support the deck was installed without flashing, creating a condition conducive to deterioration of the siding behind the ledger and possible water penetration into the dwelling. All ledger boards should be properly flashed to reduce the potential for deterioration of the deck and siding or water penetration into the dwelling.

- Moisture damage was observed on portions of the railing on the deck. All damaged materials should be removed and replaced with material treated to resist wood destroying organisms. A qualified licensed pest control contractor should be consulted for further evaluation and correction.

- The openings for the railing on the deck are too wide, which may allow a child to fall through. While this may have been acceptable at the time the deck was built, we recommend modification of the railing to eliminate safety hazards, especially for children and pets.

- The railing for the deck in the back of the house is loose. The railing should be reinforced or replaced to provide improved safety.
- There was a considerable amount of damage to the deck in the front and right side of the house, making it unsafe for use. We recommend that the deck be replaced.

- No railing was provided for the deck in the front of the house. A railing should be installed to reduce the potential for personal injury at this location.

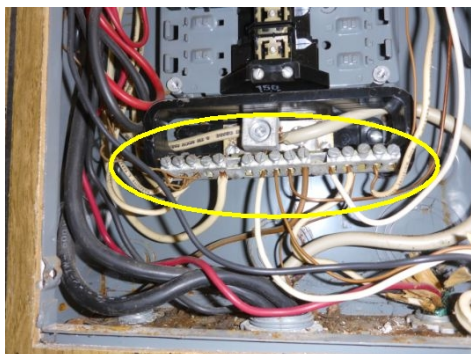
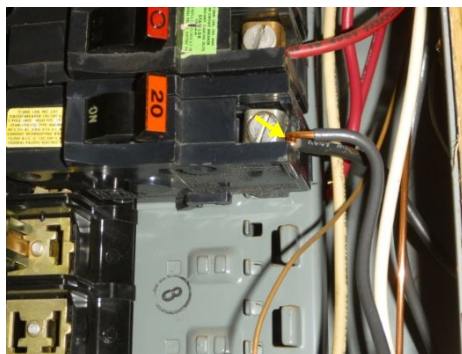
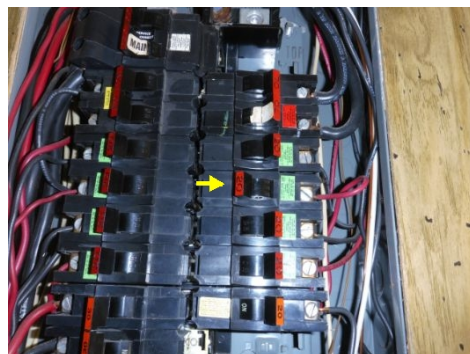
- The circuitry in the main service panel was partially labeled. Each circuit should be identified, allowing individuals unfamiliar with the equipment to properly operate it. We recommend accurately labeling the circuits by actually operating the breakers.

- Circuits within the main distribution panel that are doubled up (referred to as “double taps”) should be separated. This “double tapping” prevents a positive connection for all the wires at the terminal. Correction of “double tapping” requires reconfiguration of all of the affected circuitry so that a single wire connects to each circuit breaker terminal. We recommend repair by a qualified licensed electrician.

- The neutral/grounding terminal strip in the main distribution panel was not properly bonded to the panel. We recommend that the terminal strip be bonded to the panel by connecting a bonding jumper from the neutral terminal strip to the panel.

- A breaker in the main panel was tripped at the time of the inspection. We do not reset tripped breakers as they may have been tripped for a reason that we do not know. The circuit for this breaker could not be tested. We recommend that you consult with the owner as to the past history of this circuit and breaker, and any reason why the breaker was tripped.

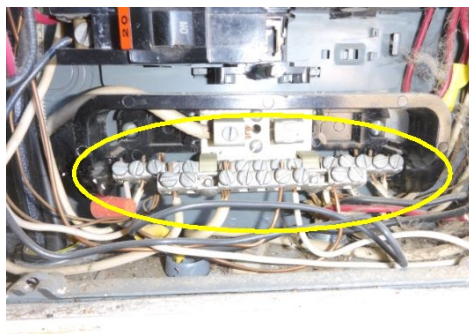
- The circuitry in the auxiliary panel was partially labeled. Each circuit should be identified, allowing individuals unfamiliar with the equipment to properly operate it. We recommend accurately labeling the circuits by actually operating the breakers.
- The grounding conductors and the neutral conductors in the auxiliary panel were connected together inside the panel. This was an improper connection. The grounding conductors should be connected to an appropriate ground terminal strip which is bonded to the enclosure, but the neutral conductors should be connected to a separate neutral terminal strip which is isolated (insulated) from the enclosure. We recommend that a qualified licensed electrician make the appropriate corrections.

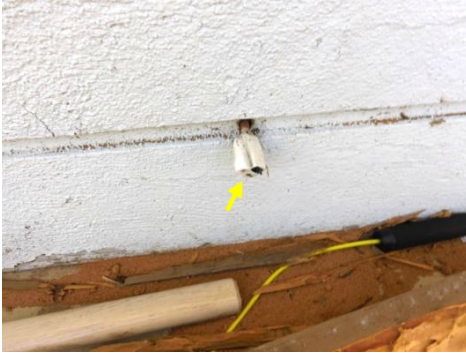
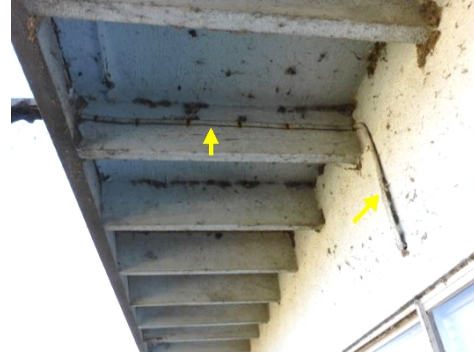
- There is unprotected wiring to the light in the back of the house, exposed to possible damage. Even if the individual conductors are insulated, wiring should not be exposed. For improved safety, it is recommended that exposed wiring be protected from damage according to the standard trade practice.

- An extension cord was utilized as permanent wiring to the light in the front of the house. Extension cords should not be used as permanent wiring as they are easy to overload and can be damaged easily. We recommended that the extension cords be replaced with proper circuitry.

- An extension cord was utilized as permanent wiring to the garage door opener. Extension cords should not be used as permanent wiring as they are easy to overload and can be damaged easily. We recommended that the extension cords be replaced with proper circuitry.

- The extension/appliance cord in the front of the house passes through a wall or ceiling. Extension/appliance cords cannot pass through a wall or ceiling as they are easy to overload and can be damaged easily. The extension cord should be removed and replaced with proper circuitry to ensure that the installation conforms to standard trade practices.

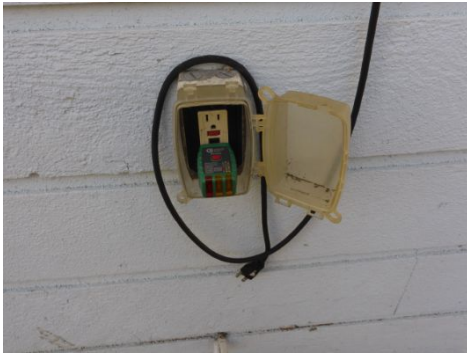
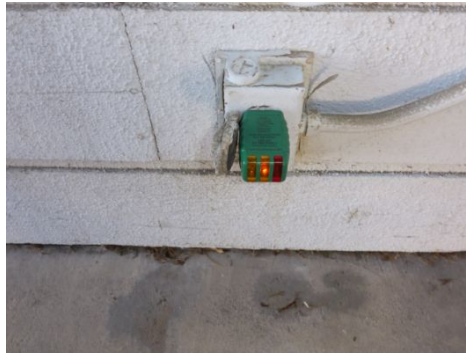
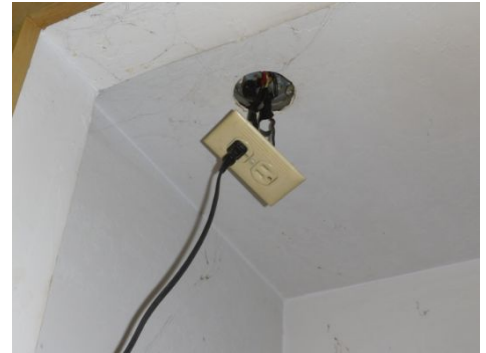
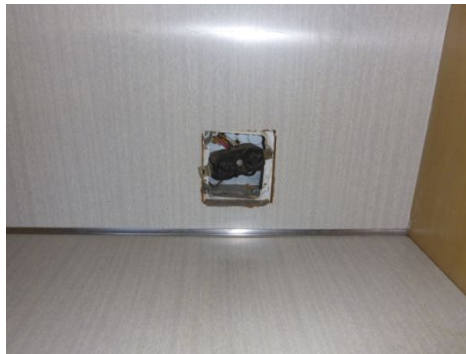
- The cover plate for a receptacle in several locations of the house was missing. All missing cover plates should be replaced with a new cover plate to restore proper protection for those who will be using the device by reducing the risk of hazardous shocks.

- The exterior weatherproof cover plate for a receptacle in the back of the house was damaged. We recommend the damaged cover plate be replaced an appropriate, exterior rated, water-resistant cover be installed to reduce the chance of moisture penetration and eliminate the safety hazard.

- A receptacle in the master bedroom closet and in the living room is loose. All loose receptacles should be properly secured or replaced as necessary.

- A receptacle in the front of the house is inoperative. All inoperative receptacles and their circuits should be investigated by a qualified licensed electrical contractor and repaired as necessary.

- Ungrounded 3-prong receptacle(s) in the back of the house should be repaired. Grounded outlets were provided in the rest of the dwelling. In this case, a ground wire may be present in the electrical box and simply needs to be connected. We recommend that a qualified licensed contractor be consulted for further evaluation and repairs as necessary.

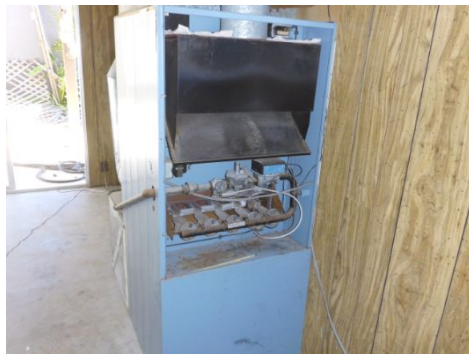
- The heater cabinet front cover was missing. We recommend that the cover be replaced.
- The thermostat for the heating system was not located or not provided, preventing a complete inspection of the heater. However, the heater was old and the heat exchanger was rusted with a buildup of soot and debris. We recommend a qualified heating technician be consulted for further evaluation and repairs or replacement as necessary.

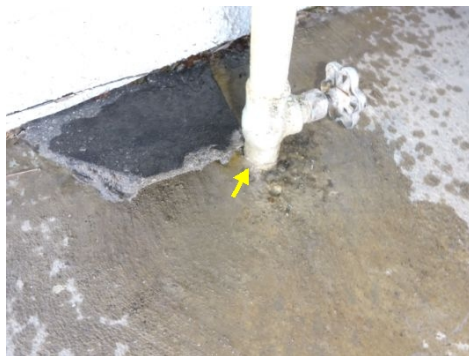
- The main water supply pipe is imbedded directly in concrete. Direct contact with concrete can cause damage from seismic movement or settlement. To help protect the pipe from damage, we recommend that this section of pipe be properly protected by a sleeve or wrap where it passes through a concrete.

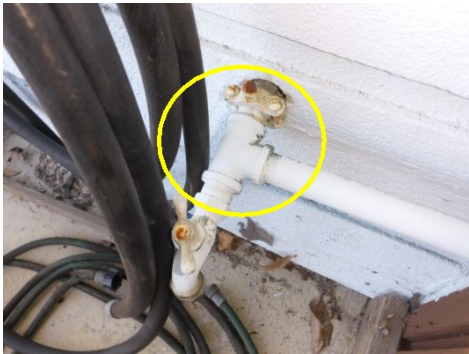
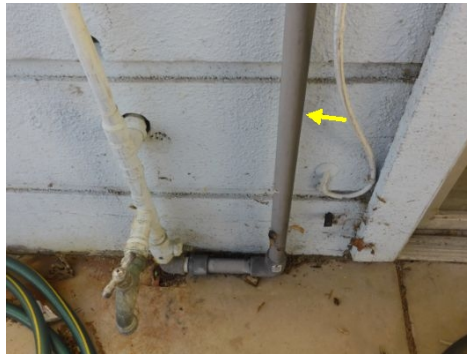
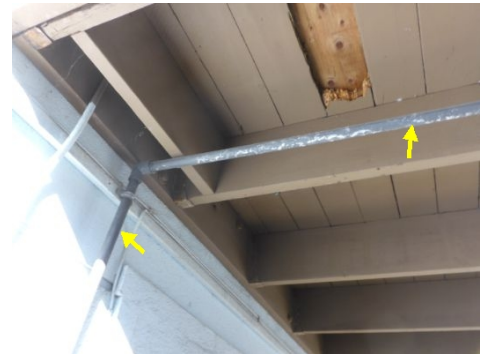
- Copper/galvanized steel pipe connections were observed on the left side of the house. These dissimilar metals cause an electronic reaction that causes premature deterioration of the pipe. We recommend that a six (6) inch brass connector be installed at all these connections to prevent premature deterioration of the pipe.
- Polyvinyl chloride (PVC) plastic piping was inappropriately installed in the domestic water supply system in the front of the house. We recommend replacing all inappropriate supply piping using new material installed in conformance with present industry standards.

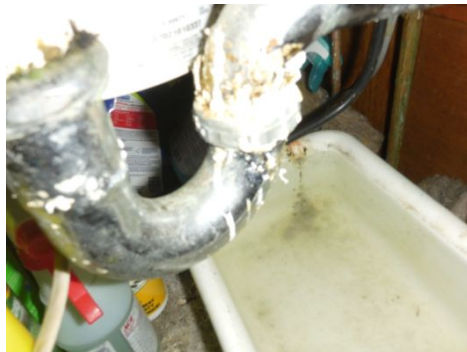
- The drain connection is leaking at the kitchen sink. A qualified licensed plumbing contractor should repair the leaking drain connection.

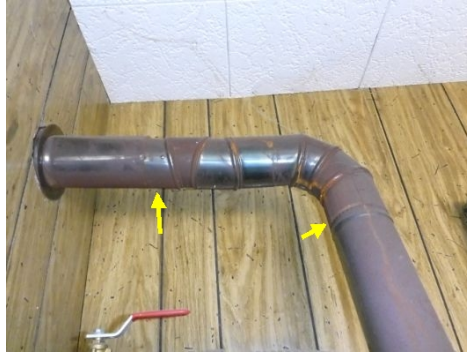
- The vent connections for the water heater were not properly connected. The vent connector should have at least 3 screws at each connection to keep the connections secure.

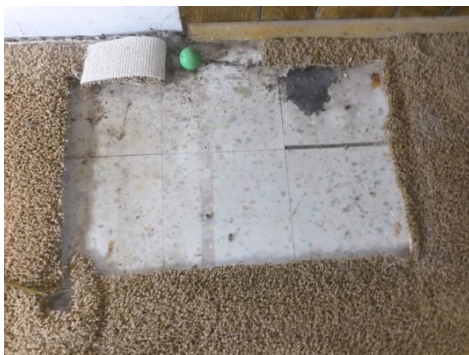
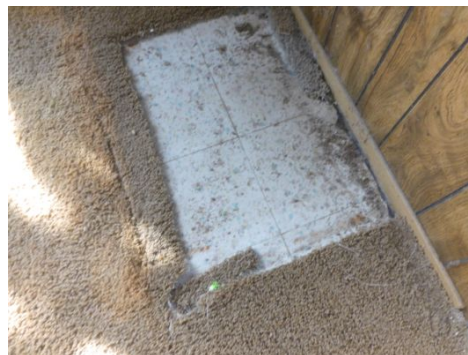
- The carpet floor covering was damaged. The floor covering in this area should be replaced.

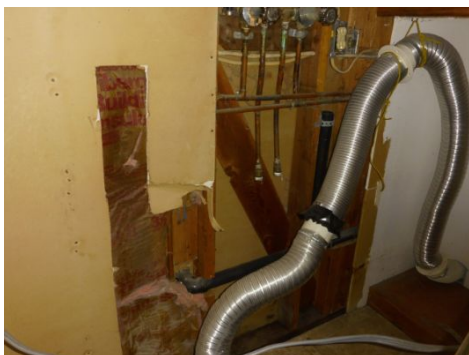
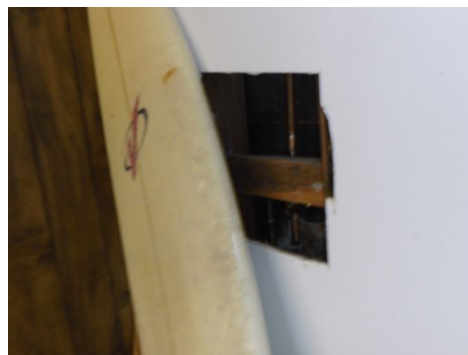
- There is a hole in the wall in several locations of the house. We recommend that any holes in the walls be repaired and restored to its original finish.

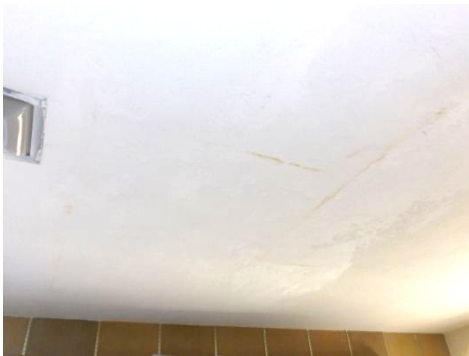
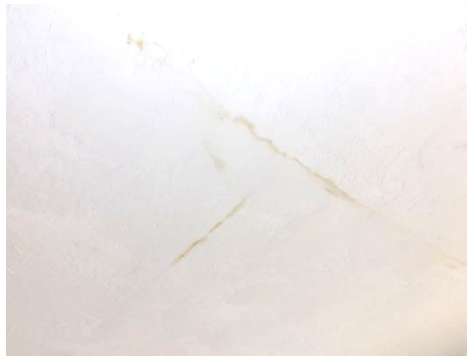
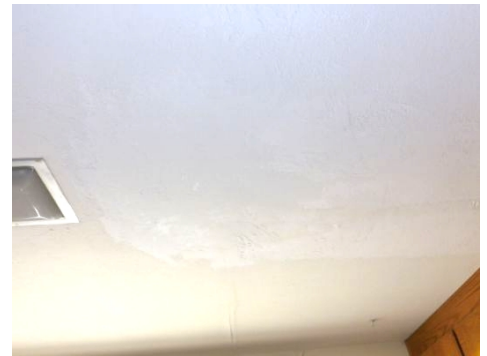
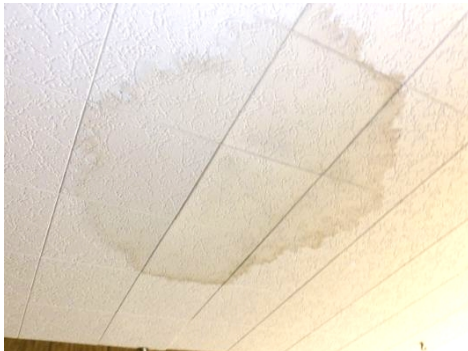
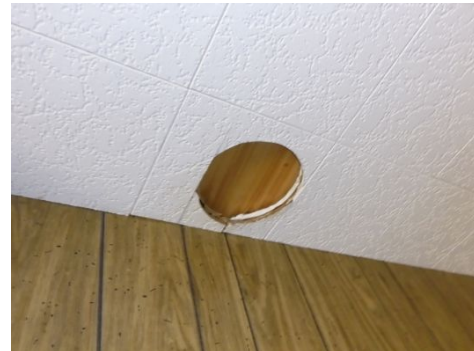
- Minor cracks were observed on the surface of the ceiling in the living room. This type of cracking in this material is common and does not indicate a structural deficiency. These cracks can be patched with a resilient material and finished in the course of routine maintenance.
- The surface of the ceiling was stained in the utility room and upper right bedroom. The source of leakage should be identified and repairs undertaken as necessary. The existing stained, damaged surface should be refinished to restore its appearance.
- Patching was observed on the ceiling in the family room. Inquiries should be made of the owner and/or occupant, who may have further knowledge regarding the history of any repairs done in this area.
- There is a hole in the ceiling in the utility room. We recommend that any holes in the ceiling be repaired and restored to its original finish.

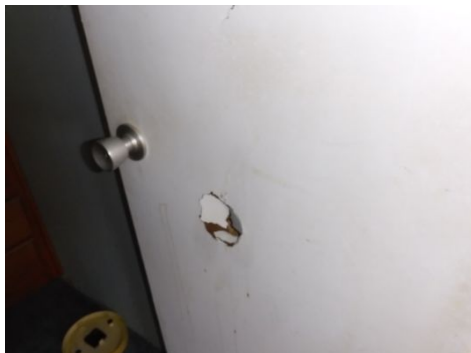
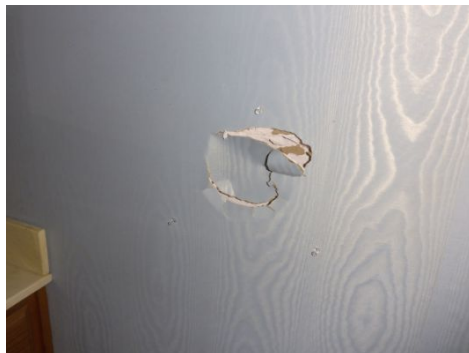
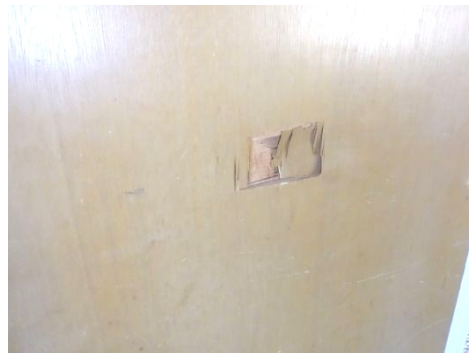
- The door in several locations of the house is damaged. We recommend that the door be repaired or replaced as necessary.

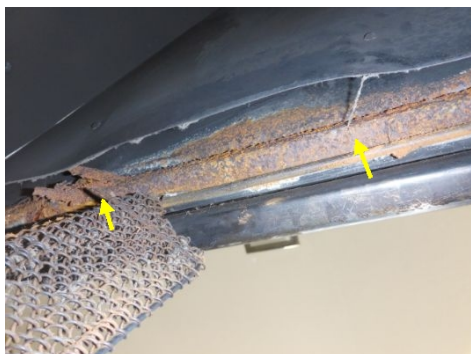
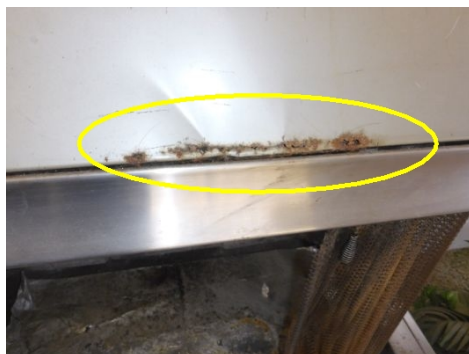
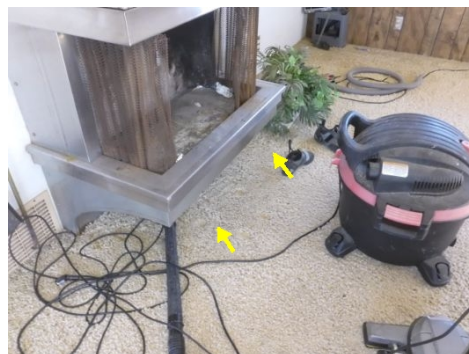
- There is no hearth extension outside the fireplace. The hearth extension should extend at least 16 inches in front of the fireplace opening and at least 8 inches beyond each side of the fireplace opening. We recommend installation of a conforming hearth extension for improved safety.
- The metal firebox for the fireplace was corroded and damaged. We recommend that a qualified licensed contractor be consulted to determine the extent of the damage and repair or replacement as necessary.

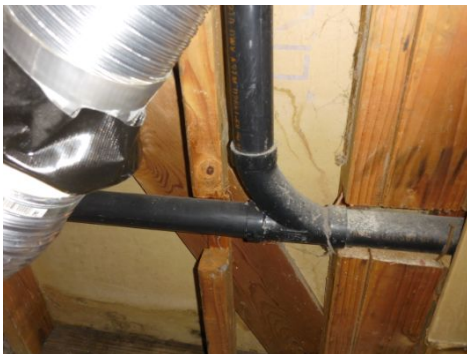
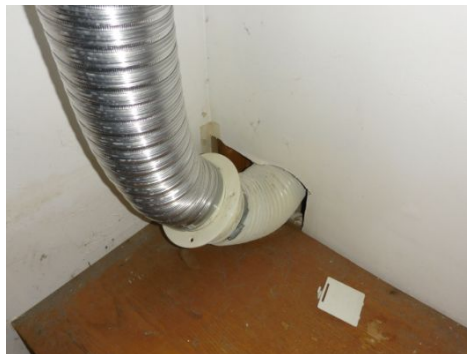
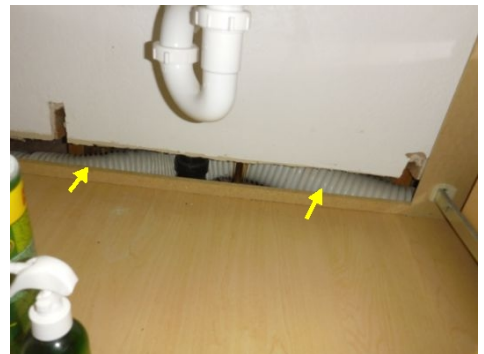
- The clothes dryer exhaust ducting was not made from an appropriate material for this location (it was a corrugated or "flexible" material). Use of an inappropriate material in this area could present a risk of fire from combustion of accumulated lint and debris. The duct from the clothes dryer vent requires a 4 inch diameter, smooth wall duct, no longer than 14 feet, with a hood damper at the exterior termination. A flexible vent (6 ft. maximum) may be used at the dryer connection only, but cannot go through underbuilding crawl spaces, floors or walls.

- A flexible vent connector was utilized for the dryer vent where it passed through a wall or floor. Flexible vent connectors are not approved for use in this application. The flexible vent connector should be replaced with materials that meet current industry standards.

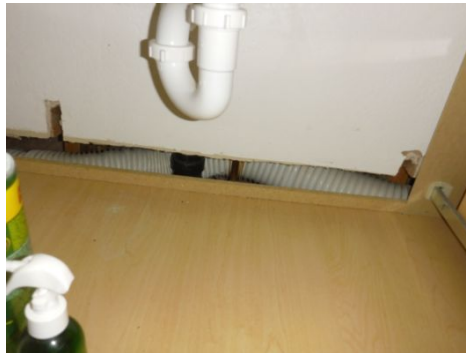
- There were holes in the wallboard under the cabinet in the laundry bathroom. We recommend these holes be properly repaired to improve appearance and as security against intrusion from insects and rodent pests.

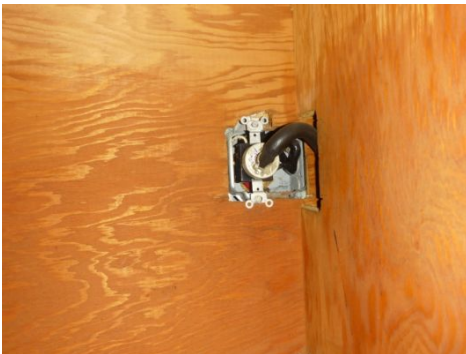
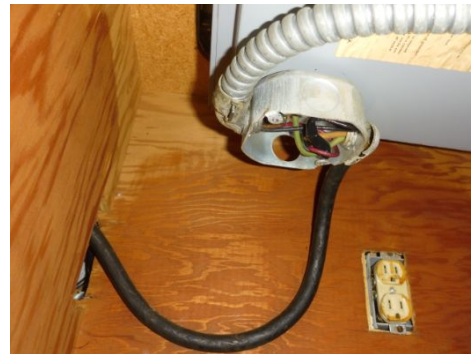
- The wiring leading to the electric cooktop was installed in a substandard manner. We recommend that a qualified licensed electrician be consulted for further evaluation and repair.

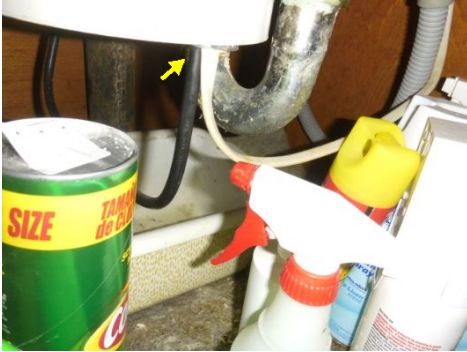
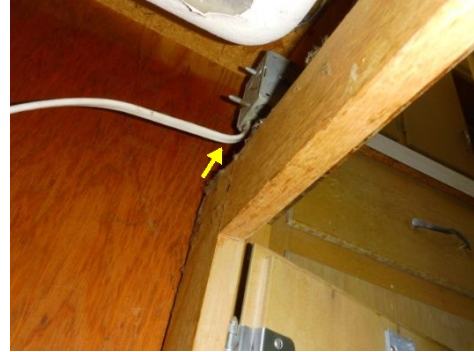
- The wiring leading to the waste disposer is installed in a substandard manner. We recommend that a qualified licensed electrician be consulted for further evaluation and repair.

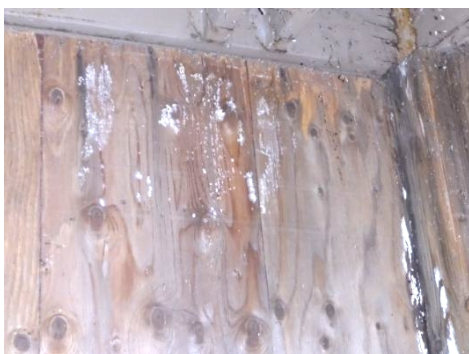
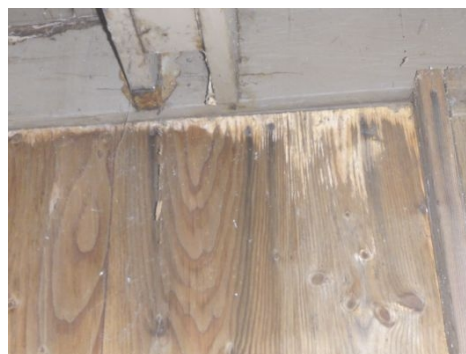
- Pronounced floor cracks were noted in the garage. While this amount of cracking is unusual, this slab is not a structural component. These cracks are basically cosmetic considerations and action would be considered optional, unless they create a trip hazard. Large cracks that create a trip hazard should be repaired for improved safety. Persisting movement may result in the need for resurfacing the garage floor.
- Moisture damage was observed on the wall sheathing in the garage. Damaged wood should be repaired or replaced as necessary and the conditions that have promoted the damage should be remedied. A qualified licensed pest control contractor should be consulted for further evaluation and correction.

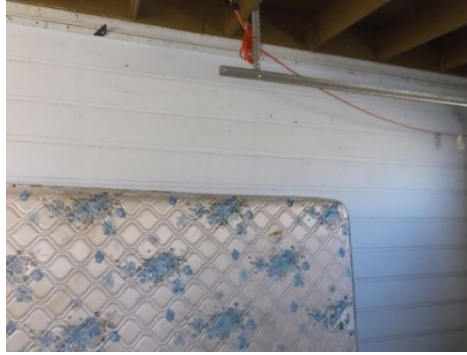
- A proper fire separation is needed at wall and ceiling finishes of attached garages where they abut the interior of the house. These walls and ceilings serve as a fire break and reduce the potential of toxic automobile gasses entering the house. We recommend that a qualified licensed contractor install such a fire separation to meet current industry standards.
