Home Inspection Report

11 S. Circle Drive, Santa Cruz

Zachary Newell
April 9, 2018

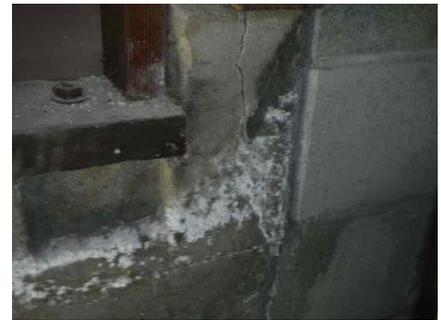
Photo 17

1. Foundation cracking and/or movement was observed in the foundation walls in the crawl space. The rate of movement cannot be predicted during a one-time inspection. A thorough evaluation of this condition is beyond our qualifications. For additional information we recommend a licensed foundation specialist be retained. (See Photo 17)

- ! 1. Foundation cracking and/or movement was observed in the foundation walls in the crawl space. The rate of movement cannot be predicted during a one-time inspection. A thorough evaluation of this condition is beyond our qualifications. For additional information we recommend a licensed foundation specialist be retained. (See Photo 17)

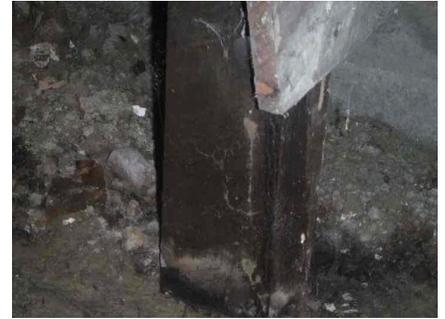
Photo 14

- 4. Wood/soil contacts at the rear right pier post of the crawl space should be eliminated. This condition is conducive to rot and wood boring insect activity. We recommend a minimum clearance of six inches be maintained between the soil and the bottom of the wood line. (See Photo 14) (See Photo 15)

- ! 4. Wood/soil contacts at the rear right pier post of the crawl space should be eliminated. This condition is conducive to rot and wood boring insect activity. We recommend a minimum clearance of six inches be maintained between the soil and the bottom of the wood line. (See Photo 14) (See Photo 15)

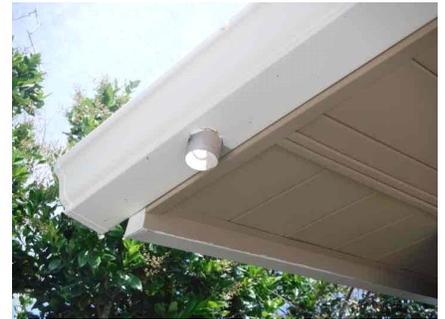
Photo 01

- 5. Missing downspouts at the front gutters should be replaced as necessary. (See Photo 1)

- ! 1. Missing downspouts at the front gutters should be replaced as necessary. (See Photo 1)
- 2. The cap of the masonry chimney has minor cracking visible which can be patched during regular household maintenance. (See Illustration 2C)
- 3. The roof and/or plumbing/appliance vent flashing should be re-caulked where worn, loose or missing.

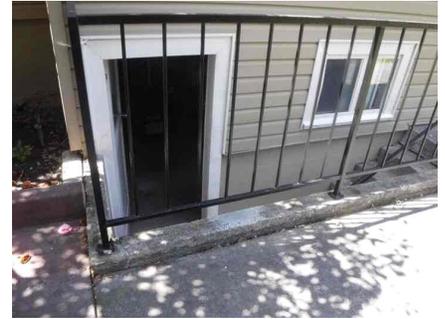
Photo 04

8. The openings in the rear railing(s) are larger than 4" inches. It is recommended that this be corrected for improved safety. (See Illustration 3N) (See Photo 4)

- ! 3. The openings in the rear railing(s) are larger than 4" inches. It is recommended that this be corrected for improved safety. (See Illustration 3N) (See Photo 4)

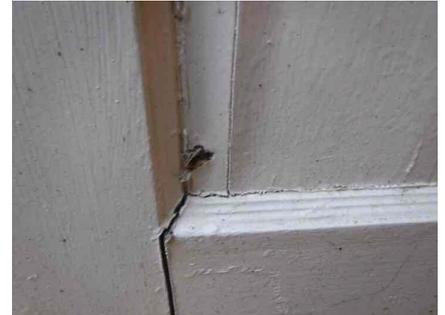
Photo 10

9. Water damage was noted at the basement door. We recommend the services of a licensed general contractor and/or structural pest control company regarding repairs. (See Photo 10)

- ! 4. Water damage was noted at the basement door. We recommend the services of a licensed general contractor and/or structural pest control company regarding repairs. (See Photo 10)

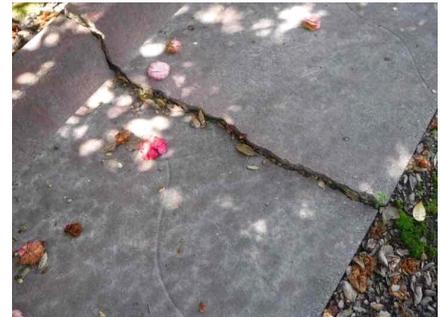
Photo 03

10. The heaved walkway section(s) at the rear and various locations present a trip hazard. This condition should be corrected for improved safety. (See Photo 3)

- ! 5. The heaved walkway section(s) at the rear and various locations present a trip hazard. This condition should be corrected for improved safety. (See Photo 3)

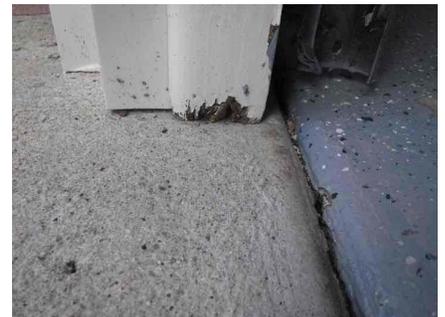
Photo 02

11. Water damage was observed to the exterior trim at the garage door. We recommend the services of a licensed general contractor and/or structural pest control company. (See Photo 2)

- ! 6. Water damage was observed to the exterior trim at the garage door. We recommend the services of a licensed general contractor and/or structural pest control company. (See Photo 2)

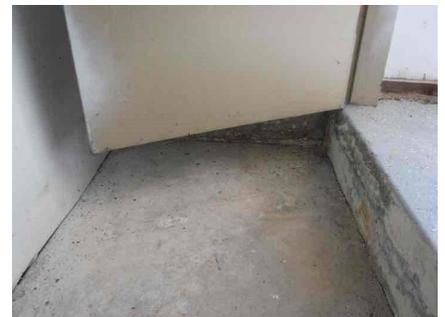
Photo 11

12. The door at the basement swings out over a step. This can be a potential hazard. We recommend that a 3'x3' landing be installed where the door swings out. (See Photo 11)

- ! 7. The door at the basement swings out over a step. This can be a potential hazard. We recommend that a 3'x3' landing be installed where the door swings out. (See Photo 11)

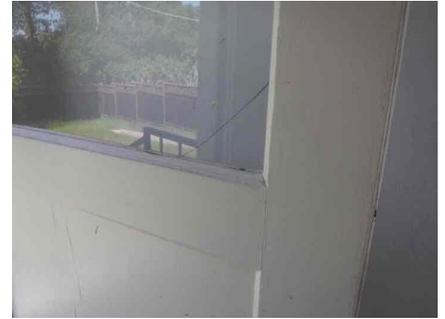
Photo 06

- 13. Cracked or broken exterior window glass in the garage man door should be replaced. (See Photo 6)

- ! 8. Cracked or broken exterior window glass in the garage man door should be replaced. (See Photo 6)
9. The concrete patio shows evidence of minor cracking. These cracks can be sealed for cosmetic considerations.

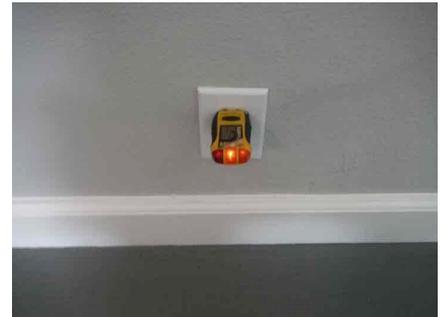
Photo 08

- 14. Ungrounded "3-prong" outlets at the living room and various locations should be improved. A grounded cable or ground wire could be installed at these outlets, the outlet labeled as ungrounded or the original "2-prong" receptacle could be reinstalled. Based upon our inspection of a representative number of outlets, we recommend testing of every outlet. Repairs or rewiring are recommended at all deficient locations. For additional information we recommend a licensed electrician be consulted. (See Illustration 4O) (See Photo 8)

- ! 1. Ungrounded "3-prong" outlets at the living room and various locations should be improved. A grounded cable or ground wire could be installed at these outlets, the outlet labeled as ungrounded or the original "2-prong" receptacle could be reinstalled. Based upon our inspection of a representative number of outlets, we recommend testing of every outlet. Repairs or rewiring are recommended at all deficient locations. For additional information we recommend a licensed electrician be consulted. (See Illustration 4O) (See Photo 8)

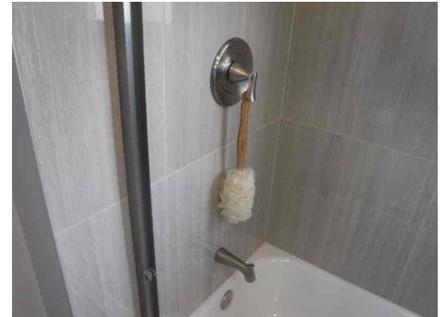
Photo 09

- 15. The shower at the hall bathroom has no water output and was inoperable. We recommend contacting a licensed plumber to further evaluate this area. (See Photo 9)

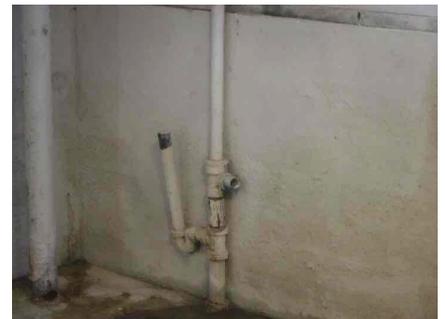
Photo 13

- 16. There is an open drain pipe at the drain of the basement. This is a potential health hazard. We recommend the piping in question be repaired or replaced as necessary. (See Photo 13)

- ! 1. There is an open drain pipe at the drain of the basement. This is a potential health hazard. We recommend the piping in question be repaired or replaced as necessary. (See Photo 13)
- 2. The main water shut-off handle is partially buried. We recommend the valve be fully exposed for ease of operation. This would be especially important in an emergency.
- ! 3. The shower at the hall bathroom has no water output and was inoperable. We recommend contacting a licensed plumber to further evaluate this area. (See Photo 9)

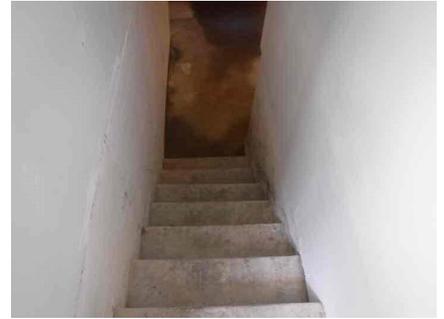
Photo 12

17. There is no railing where needed at the basement staircase. For improved safety, it is recommended that appropriate railing be installed. (See Photo 12)

- ! 1. There is no railing where needed at the basement staircase. For improved safety, it is recommended that appropriate railing be installed. (See Photo 12)

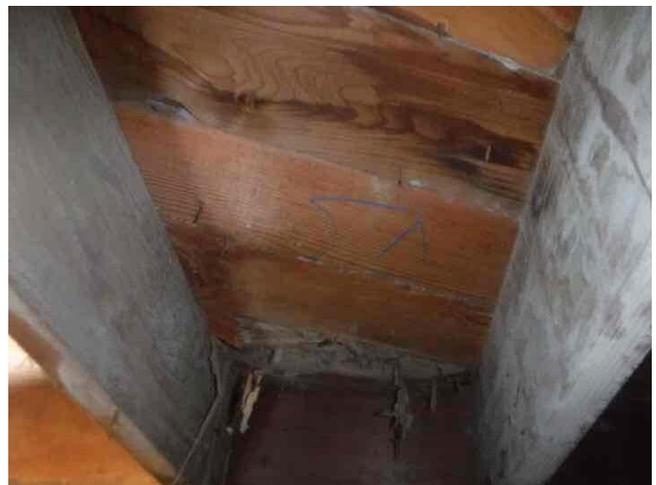
Photo 16

3. The wood members under the front wall show evidence of water damage. We recommend the services of a licensed structural pest control operator for investigation of this condition. (See Photo 16)

- ! 3. The wood members under the front wall show evidence of water damage. We recommend the services of a licensed structural pest control operator for investigation of this condition. (See Photo 16)

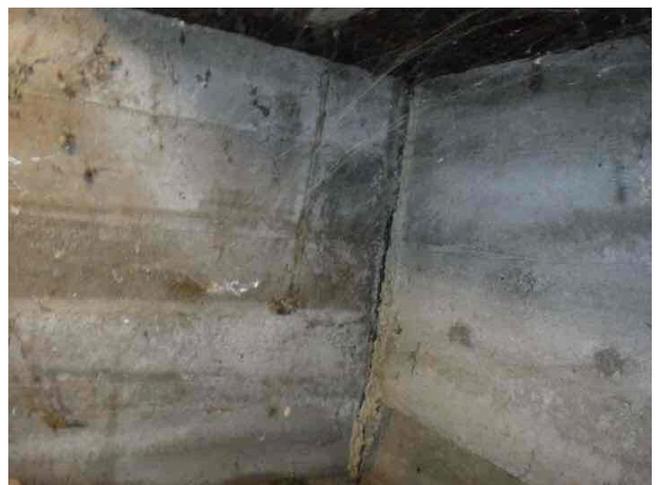
Photo 18

2. Substantial foundation cracking, deterioration and/or movement was observed in the foundation walls at the rear right of the crawl space. This implies that structural movement of the building may have occurred. The rate of movement cannot be predicted during a one-time inspection. A structural engineer should be consulted to further evaluate this condition. (See Photo 19) (See Photo 18)

- ! 2. Substantial foundation cracking, deterioration and/or movement was observed in the foundation walls at the rear right of the crawl space This implies that structural movement of the building may have occurred. The rate of movement cannot be predicted during a one-time inspection. A structural engineer should be consulted to further evaluate this condition. (See Photo 19) (See Photo 18)
