Home Inspection Report

11 S. Circle Drive, Santa Cruz

Zachary Newell
April 9, 2018

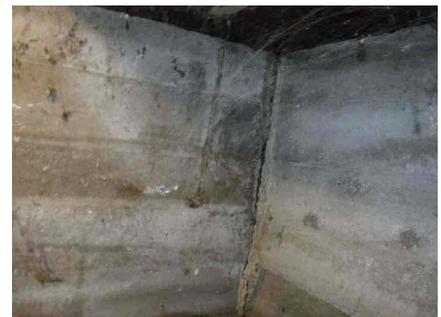
Photo 18

2. Substantial foundation cracking, deterioration and/or movement was observed in the foundation walls at the rear right of the crawl space. This implies that structural movement of the building may have occurred. The rate of movement cannot be predicted during a one-time inspection. A structural engineer should be consulted to further evaluate this condition. (See Photo 19) (See Photo 18)

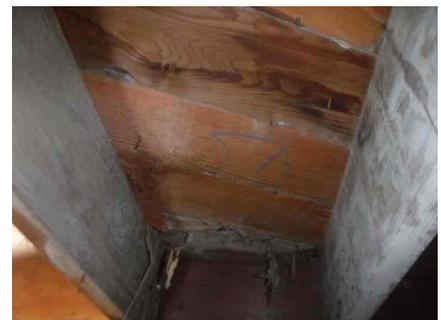
Photo 16

3. The wood members under the front wall show evidence of water damage. We recommend the services of a licensed structural pest control operator for investigation of this condition. (See Photo 16)

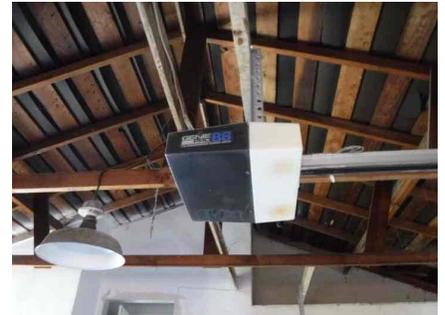
Photo 05

- 6. The garage door opener did not automatically reverse under normal resistance to closing. There is a serious risk of injury, particularly to children. Improvement may be as simple as adjusting the sensitivity control on the opener. This should be dealt with immediately. Information on garage door openers is available from the Consumer Product Safety Commission at 1(800) 638-2772. (See Illustration 3V) (See Photo 5)

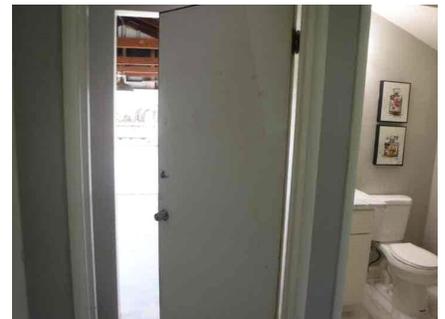
Photo 07

- 7. The door between the garage and the house did not have an automatic closing mechanism. The door between the garage and the interior of the house should be fitted with an automatic closing mechanism. This will reduce the potential of toxic automobile gases entering the house and serves as a fire break. (See Illustration 3G) (See Photo 7)

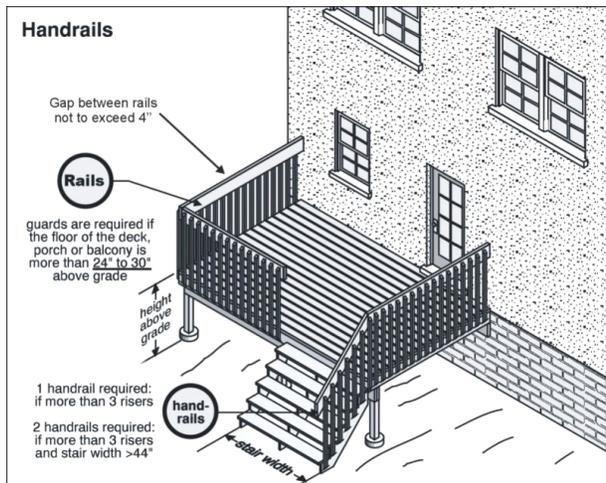
Illustration 3N

8. The openings in the rear railing(s) are larger than 4" inches. It is recommended that this be corrected for improved safety. (See Illustration 3N) (See Photo 4)

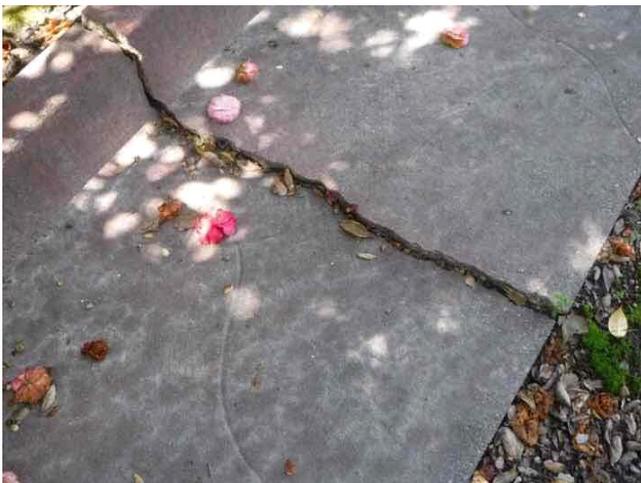
Photo 03

10. The heaved walkway section(s) at the rear and various locations present a trip hazard. This condition should be corrected for improved safety. (See Photo 3)

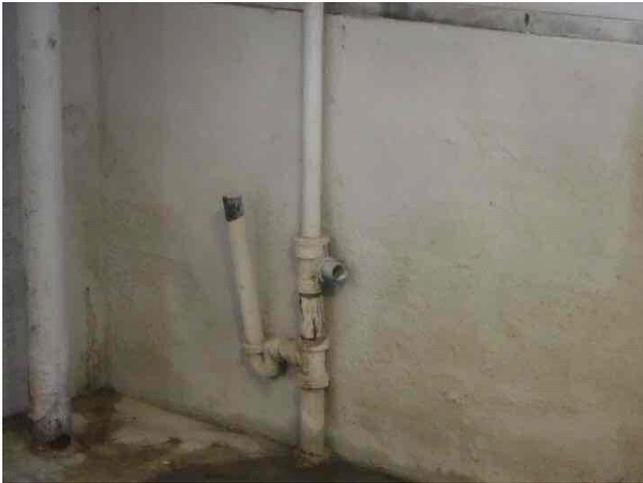
Photo 13

- 16. There is an open drain pipe at the drain of the basement. This is a potential health hazard. We recommend the piping in question be repaired or replaced as necessary. (See Photo 13)

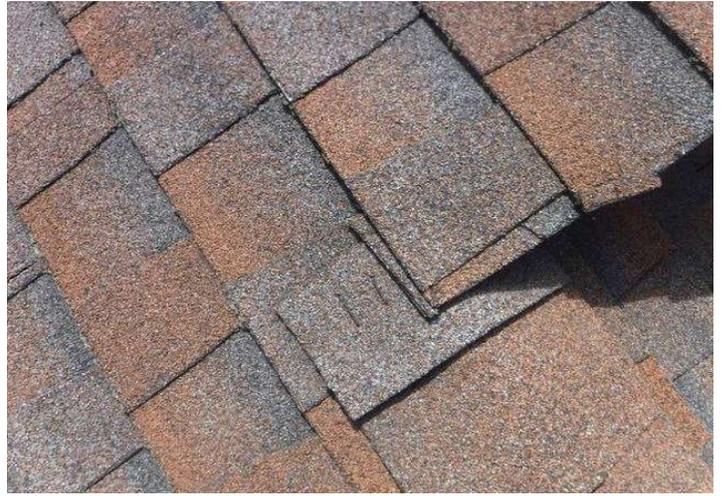
Photo 2

2. There are exposed fasteners in the field that may leak if not sealed. (See Photo 2) (See Photo 3)
RECOMMENDATION:
Seal any exposed fasteners in the field.

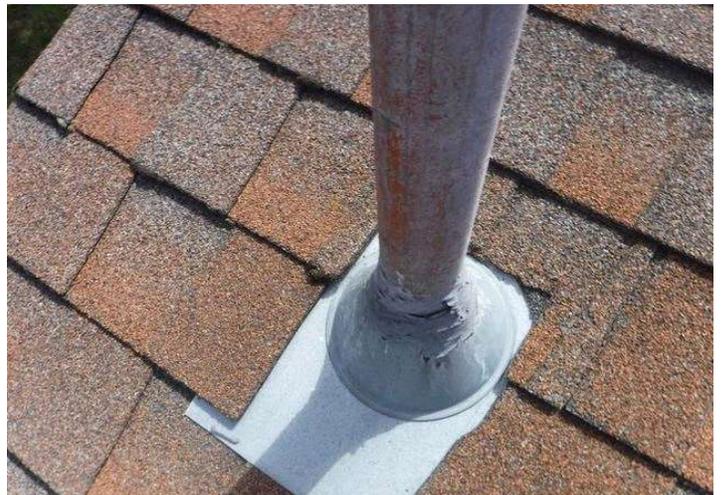
Photo 4

3. The plumbing jack flashing are not adequately sealed at the collars. (See Photo 4)
RECOMMENDATION:
Seal all plumbing vent collars where needed to ensure a watertight condition.

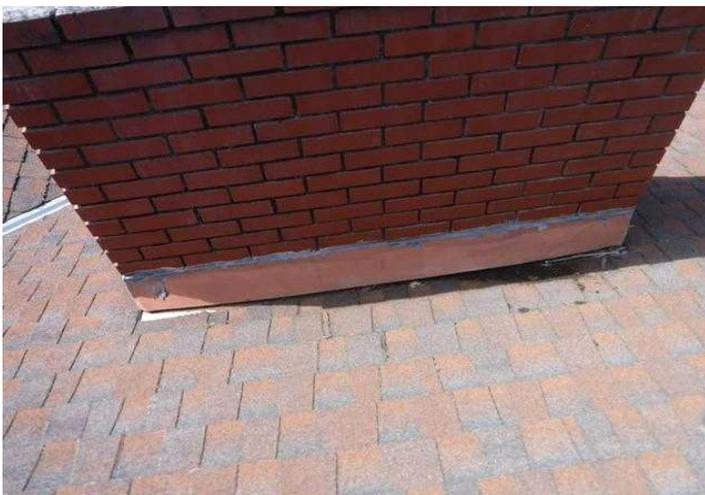
Photo 5

4. The chimney is over 48", it is recommended to install a cricket for chimneys over 48". (See Photo 5)
RECOMMENDATION:
Install a cricket at the chimney.

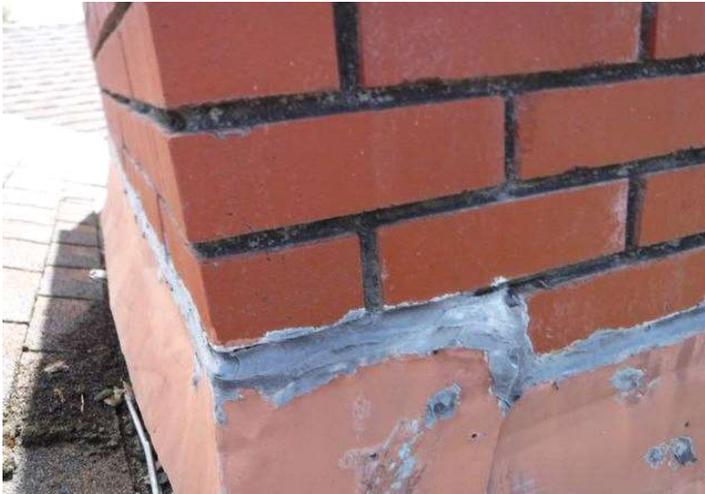
Photo 6

5. The chimney flashing is not properly integrated into the roofing system, the water shedding ability of this area cannot be guaranteed. (See Photo 6)
RECOMMENDATION:
Properly integrate the chimney flashing into the roof system, where needed to ensure a water impermeable condition.

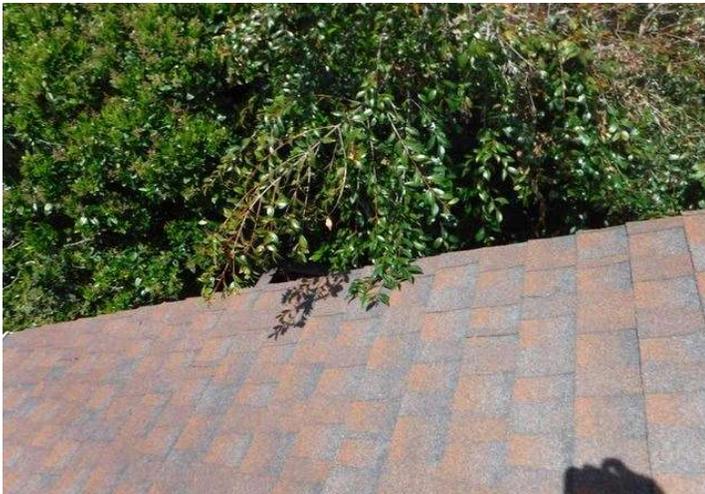
Photo 8

7. A tree is overhanging the roof's surface. Under windy conditions the branches will rub against the roof causing subsequent damage to the roof surface. To prevent premature roof wear, owner is to trim away all tree branches that can potentially rub against the surface of the roof. (See Photo 8) (See Photo 9)
8. The roof to wall flashing is not properly integrated into the roofing system, the water shedding ability of this area cannot be guaranteed. (See Photo 10) (See Photo 11)

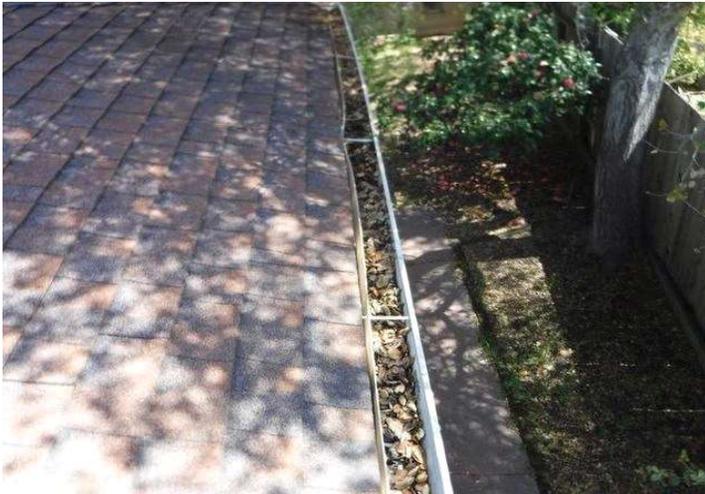
Photo 12

9. The eave edges have been installed without a proper drip edge. This condition will lead to premature wear and tear at these locations. (See Photo 12) (See Photo 14) (See Photo 16) (See Photo 19)

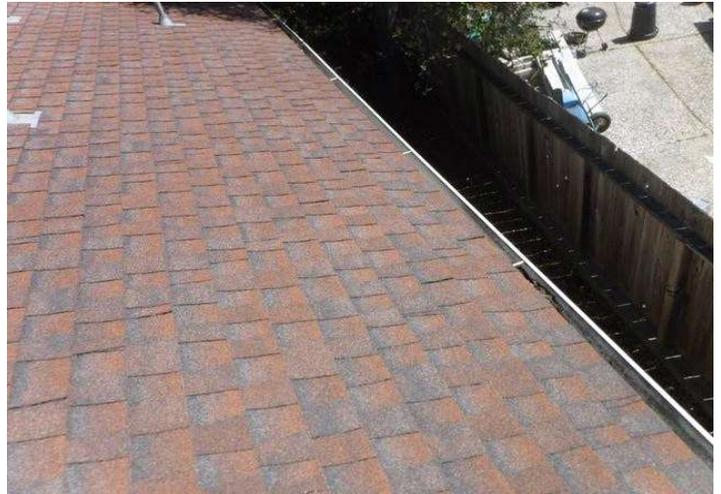
Photo 13

10. The rain gutters have pulled away from the eaves, this condition does not promote proper drainage at the roof's edge. The owner is advised to contact a sheet metal contractor, or someone in this line of work, to inspect the gutter system and make any recommendations and/or repairs deemed necessary. (See Photo 13)
11. Debris was noted to be collecting in the gutter system. The owner is advised to contact a sheet metal contractor, or someone in this line of work, to inspect the gutter system and make recommendations and/or repairs deemed necessary. (See Photo 13)
12. We noted corroded chimney flashing(s), this condition allows direct water entry into the structure. (See Photo 15)

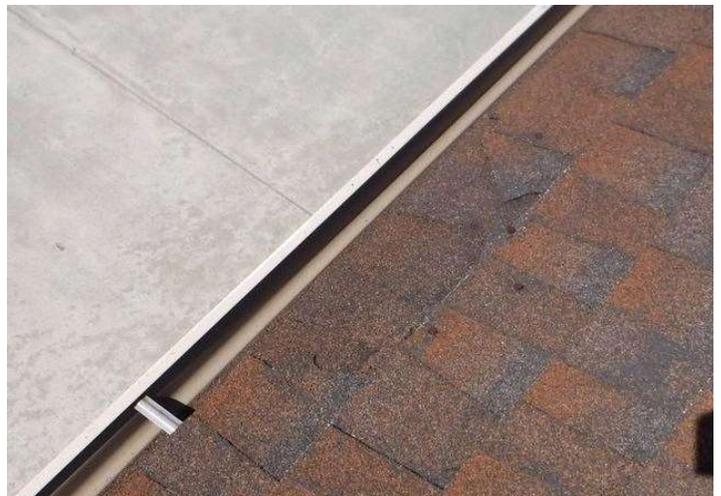
Photo 17

13. There are damaged shingles in the field. (See Photo 17) (See Photo 18)
